## **Test Report: Testing of Panel Durability to Specific Cleaning Solvents**

Arcoplast

EAG Job #V1HWU286

V1HWU286 Evaluate client provided test panels using a modified ASTM D1308 method

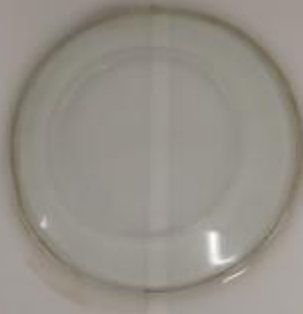
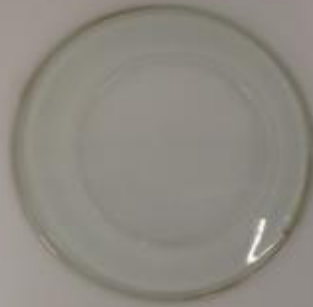
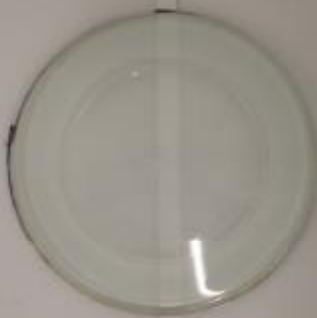
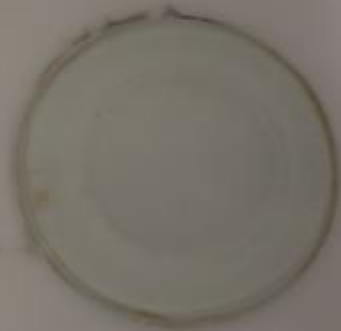
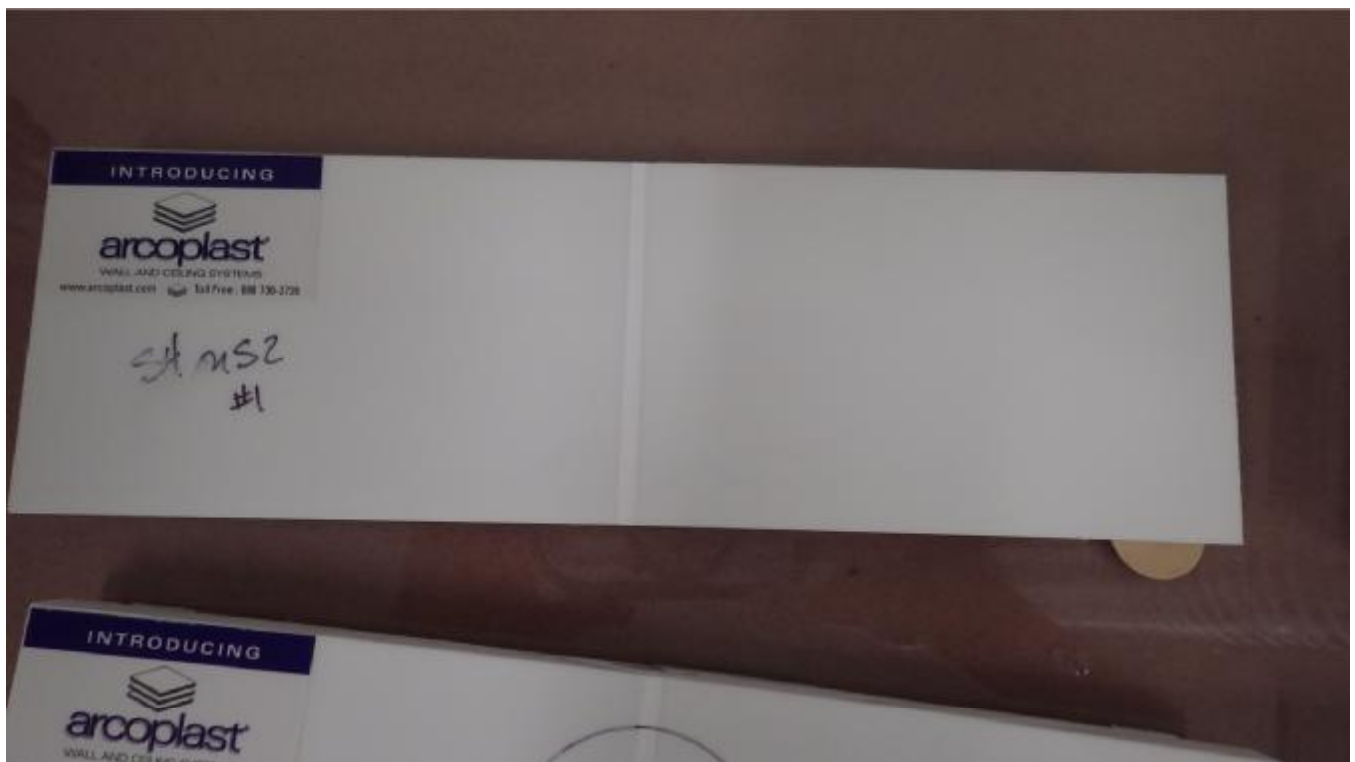
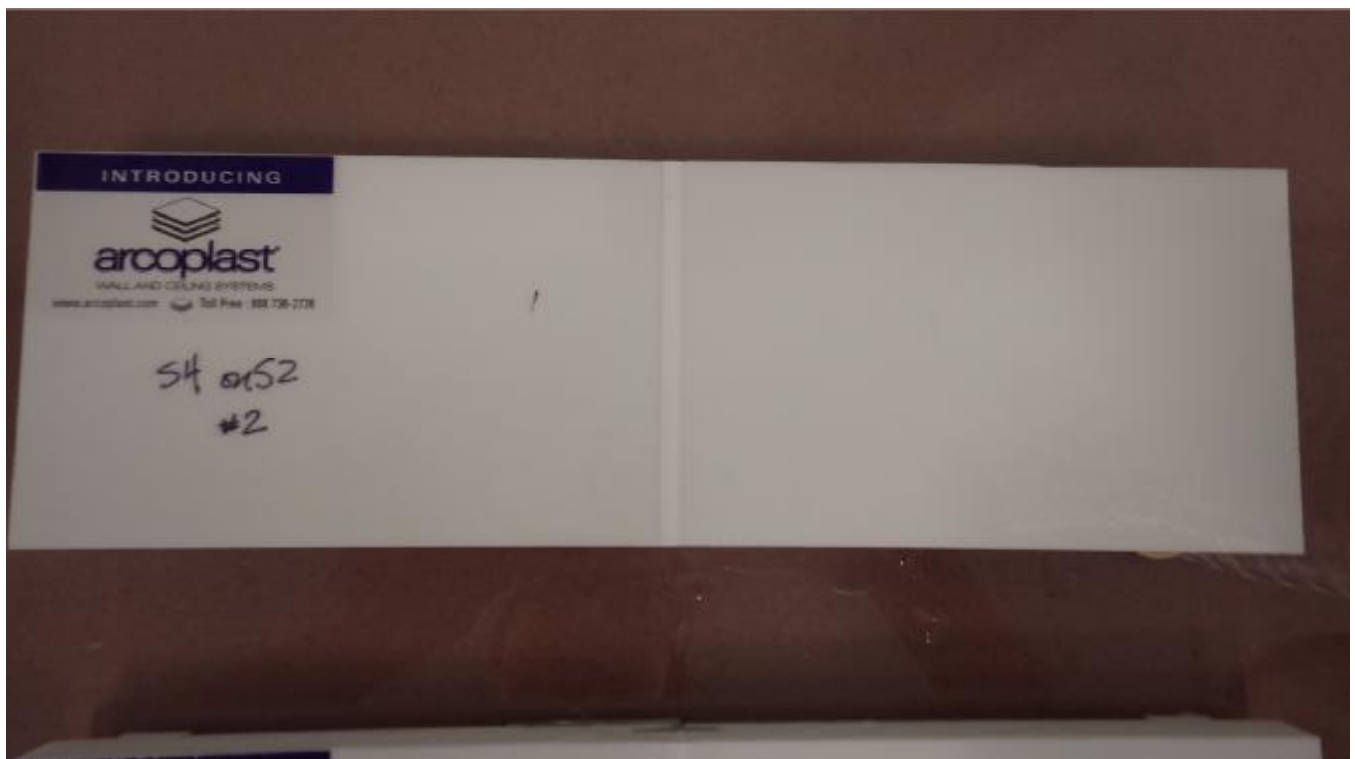
ATTACHMENT 1

| CHEMICAL | DEFECTS FROM CHEMICAL RESISTANCE TESTING FOR GLASS/RESIN MATRIX | DEFECTS FROM CHEMICAL RESISTANCE TESTING FOR SEALANT |
|---|---|---|
| S4 – Steris Coverage Plus NPD One-Step Cleaner Disinfectant | No observable change | No observable change |

S2 - Solid Core with Class A Fire Retardant  
White A-8016  
tested with  
S4 (Coverage Plus NPD)  
*As Received before, during and after 72 hours*

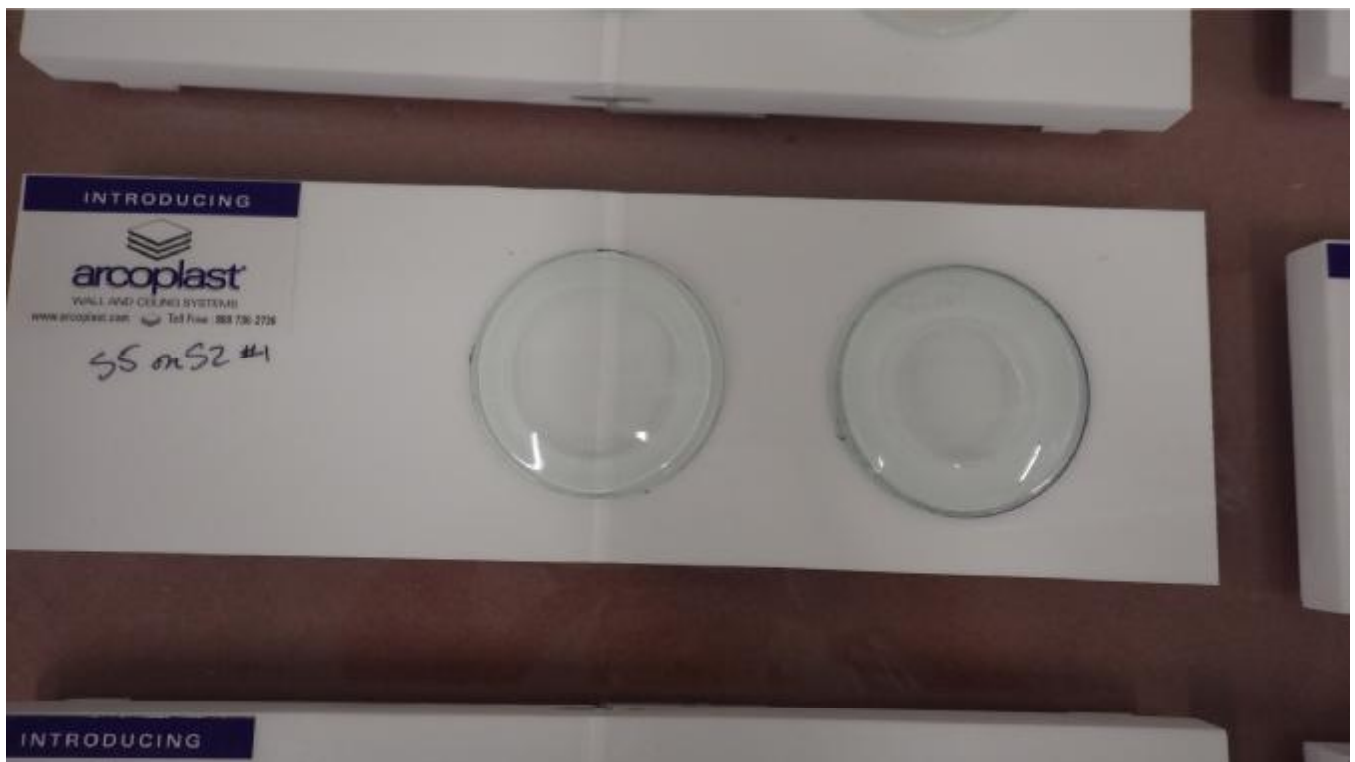
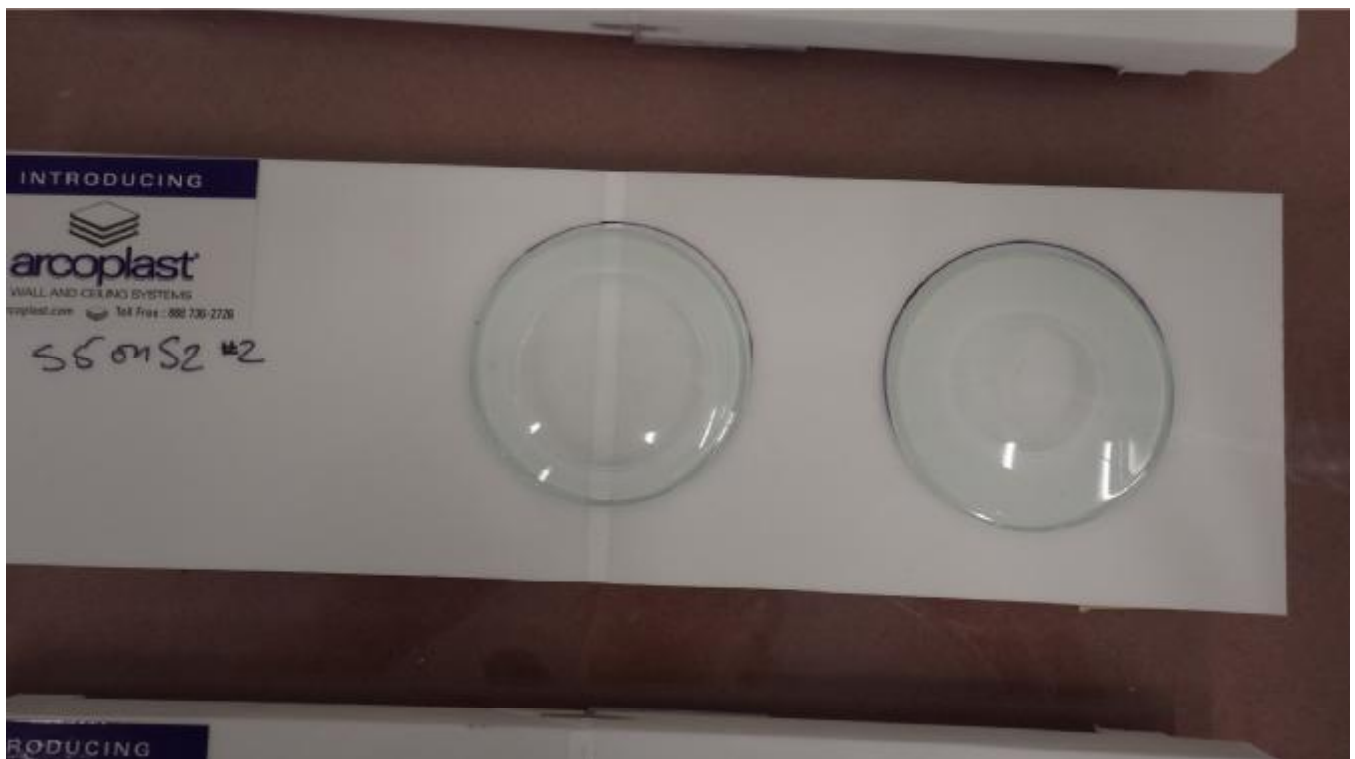
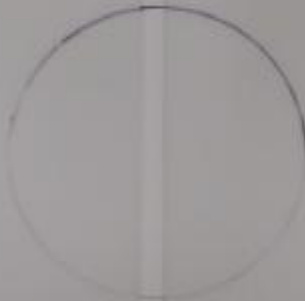
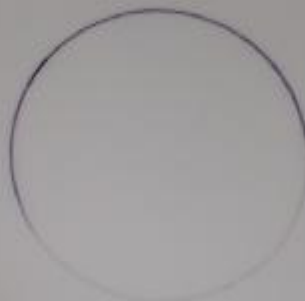
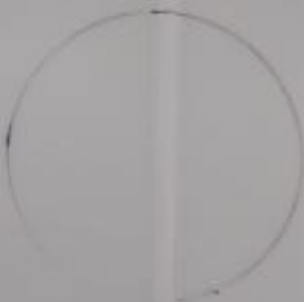
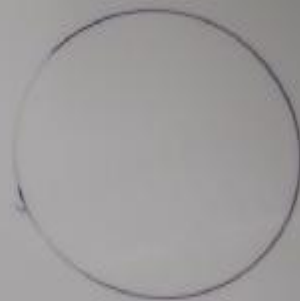
ATTACHMENT 2

| CHEMICAL | DEFECTS FROM CHEMICAL RESISTANCE TESTING FOR GLASS/RESIN MATRIX | DEFECTS FROM CHEMICAL RESISTANCE TESTING FOR SEALANT |
|---|---|---|
| S5 – Steris SPOR-KLENZ Ready to Use Cold Sterilant | No observable change | No observable change |

S2 - Solid Core with Class A Fire Retardant  
White A-8016  
tested with  
S5 (SPOR-KLENZ Ready to Use)  
*As Received before, during and after 72 hours*

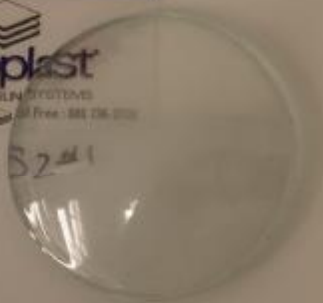
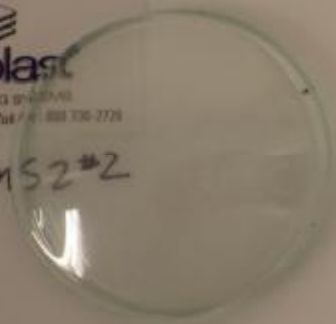
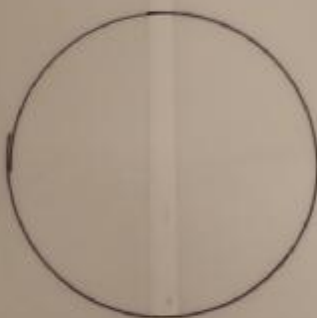
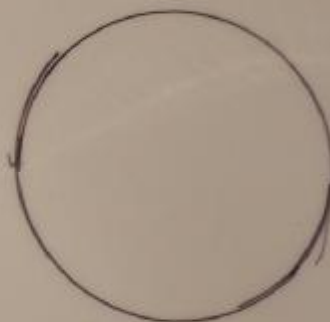
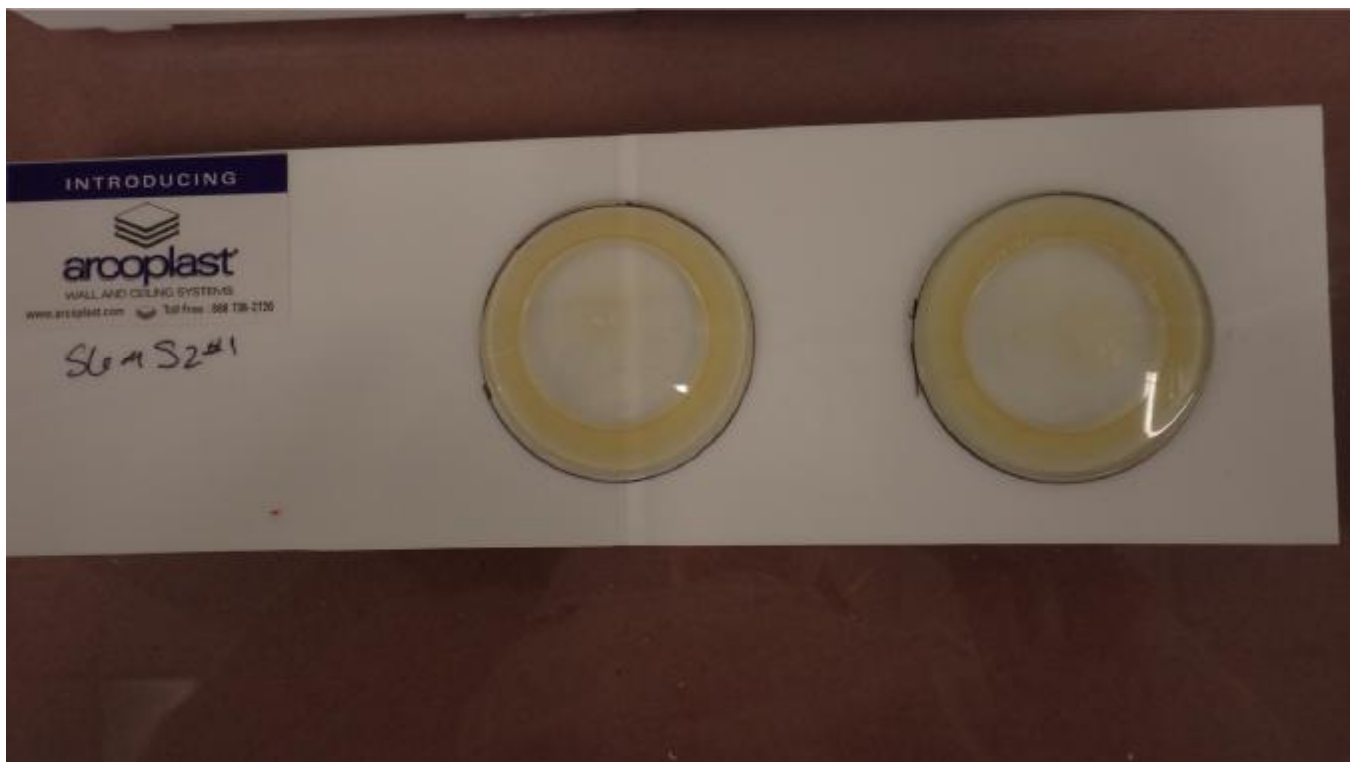
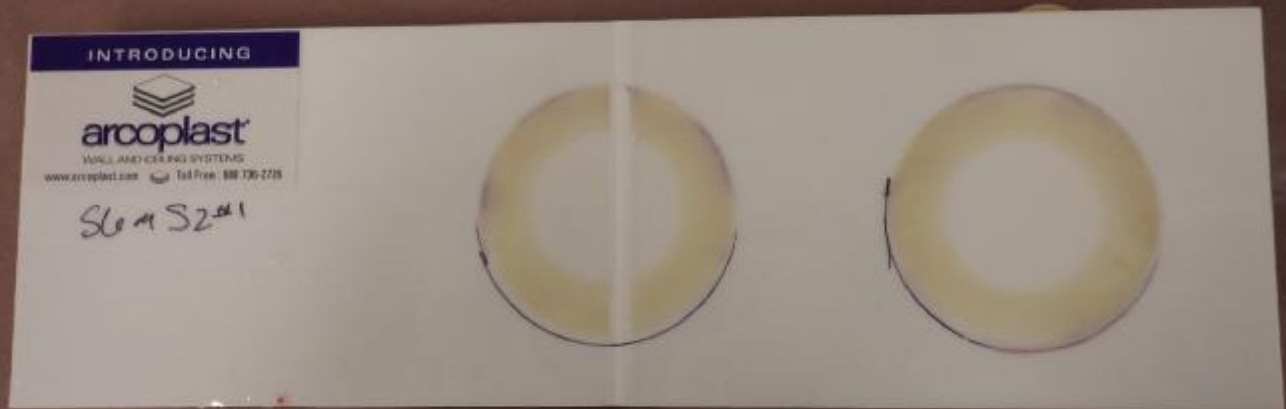
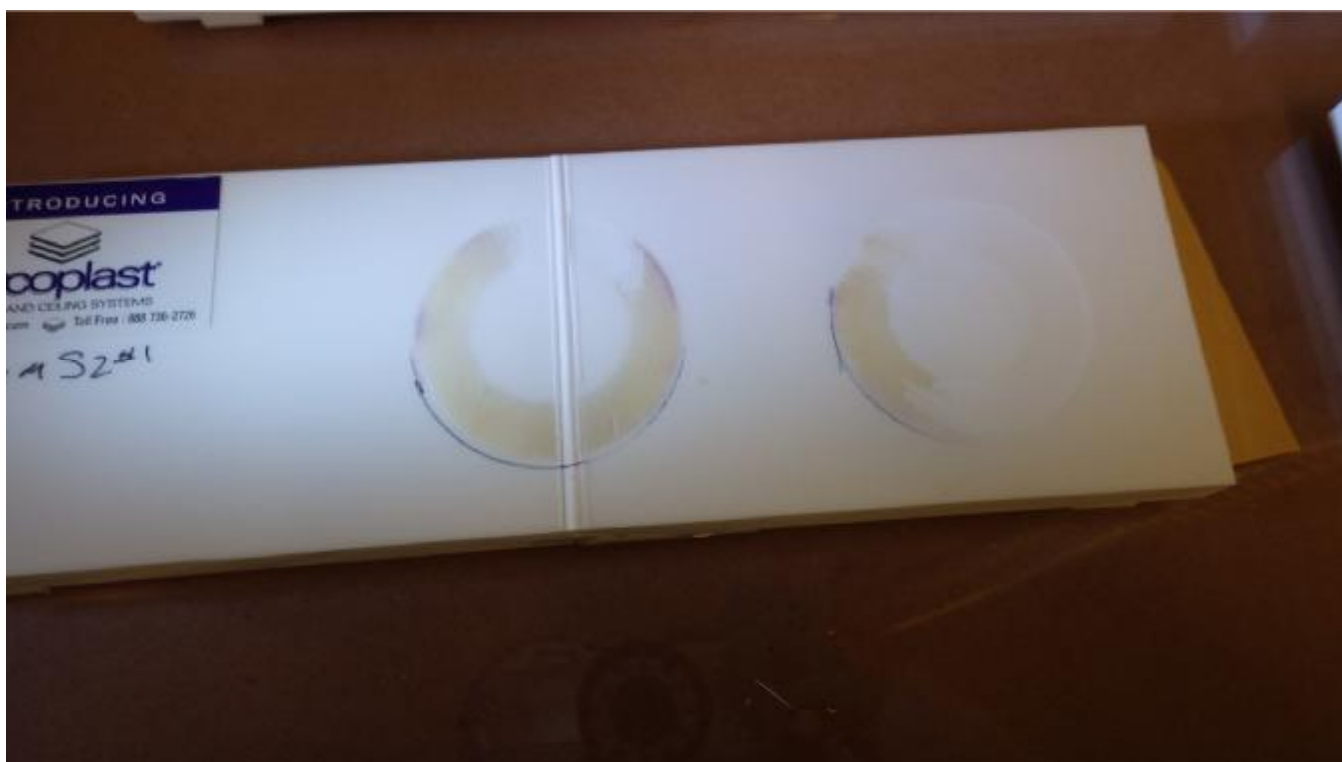
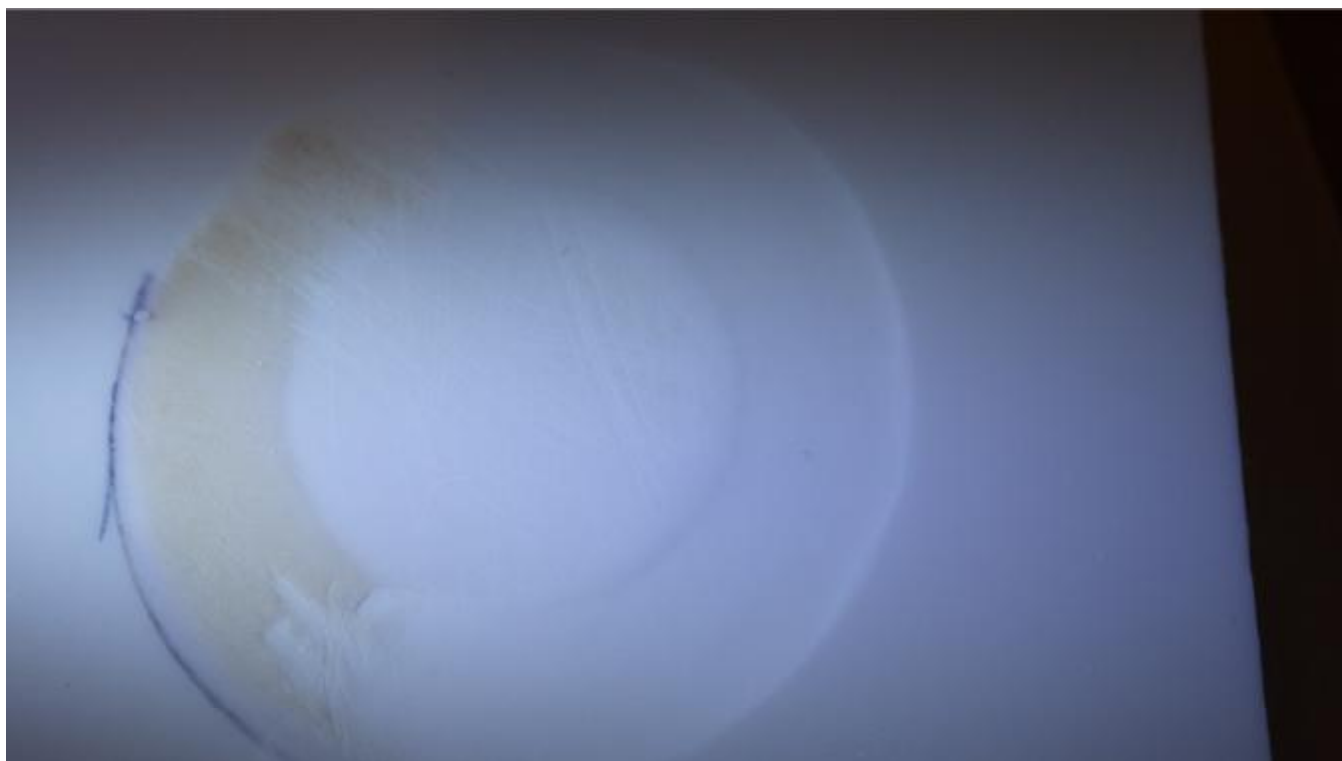
ATTACHMENT 3

Of the three Steris cleaning solutions received, only the S6 material (LpH se One-Step Germicidal Detergent) tested in the “as received” state negatively impacted the provided client panels surface, though not the sealant material. When the S6 material was diluted to the manufacturer recommended conditions, the test panel was not observably impacted event at the exposure times of 72 hours.

| CHEMICAL | DEFECTS FROM CHEMICAL RESISTANCE TESTING FOR GLASS/RESIN MATRIX | DEFECTS FROM CHEMICAL RESISTANCE TESTING FOR SEALANT |
|---|---|---|
| S6 – Steris LpH se One-Step Germicidal Detergent | Gloss loss, substrate considerably etched away | No observable change |

S2 - Solid Core with Class A Fire Retardant  
White A-8016  
tested with  
S6 ( LpH se)

*As Received before, during and after 72 hours*

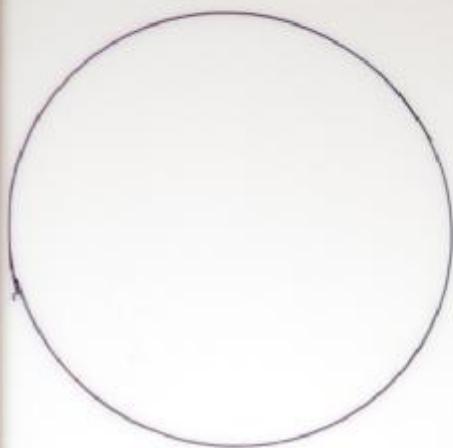
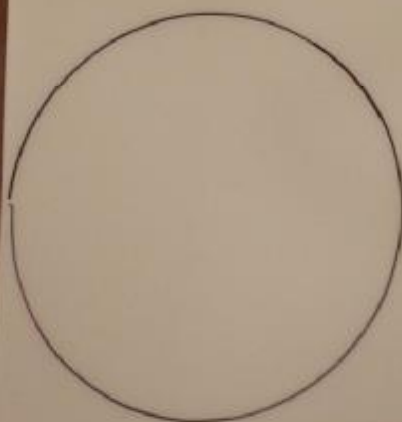
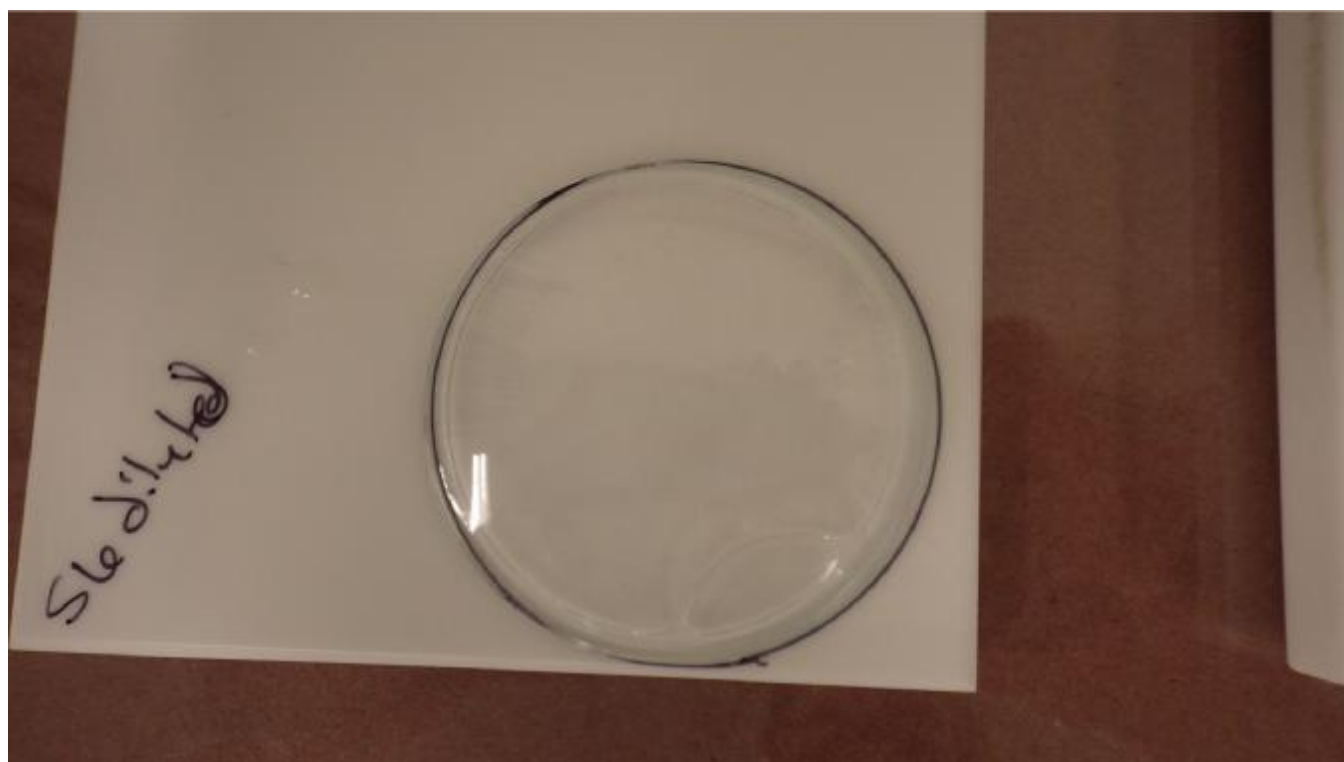
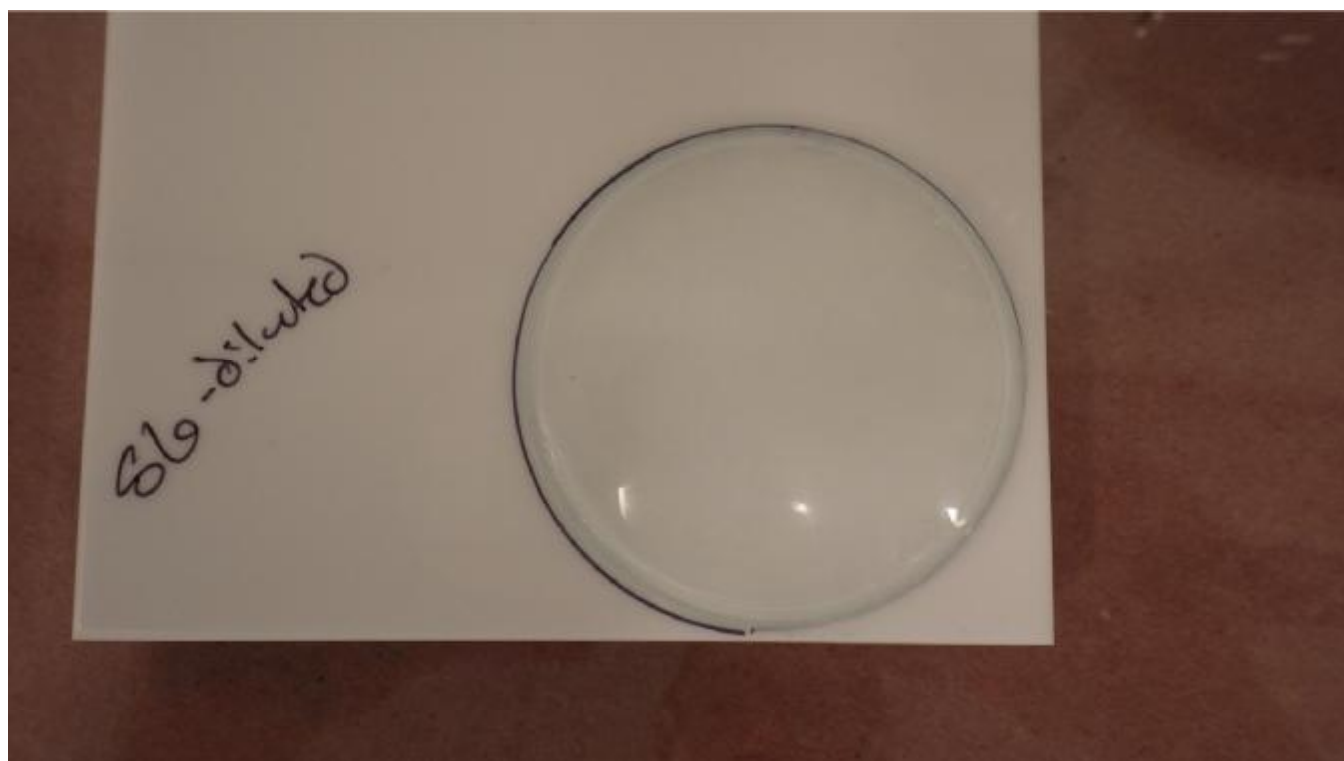
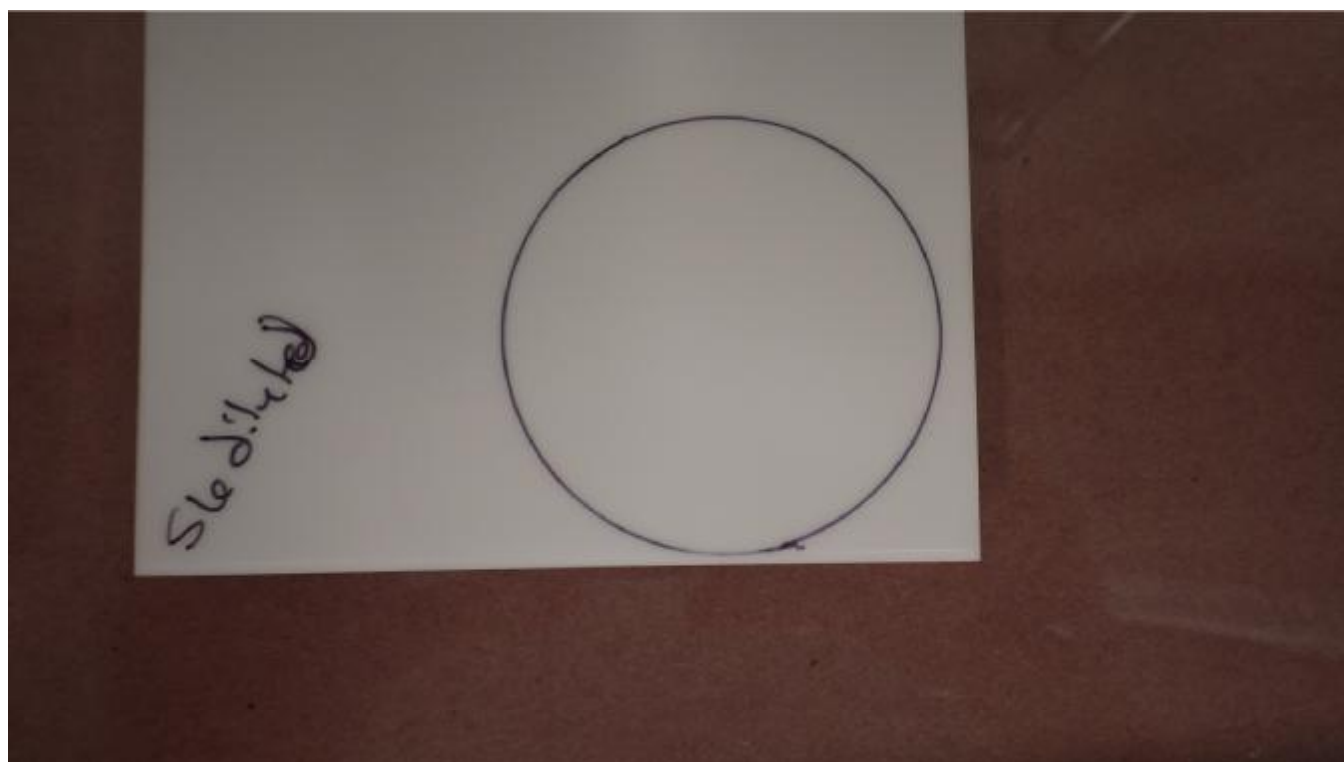
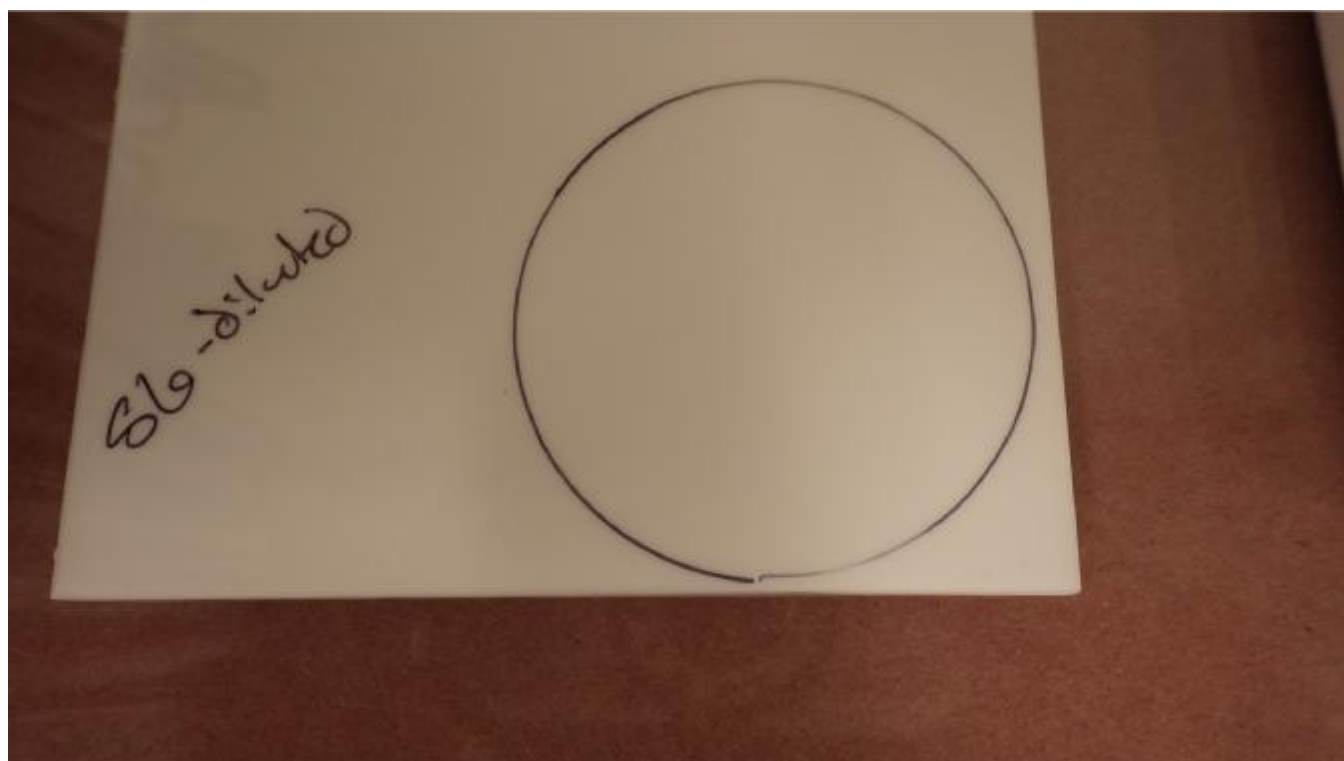
ATTACHMENT 4

| CHEMICAL | DEFECTS FROM CHEMICAL RESISTANCE TESTING FOR GLASS/RESIN MATRIX | DEFECTS FROM CHEMICAL RESISTANCE TESTING FOR SEALANT |
|---|---|---|
| S6 – Steris LpH se One-Step Germicidal Detergent Diluted to Manufacturer Recommendations | No observable change | |

S2 - Solid Core with Class A Fire Retardant  
White A-8016  
tested with  
S6 ( LpH se)  
*Diluted before, during and after 72 hours*
